DESCRIPTIVE REPORT (HYDROGRAPHIC)

State California
General Locality .. San Francisco
Locality North & South Piers of
..... Golden Gate Bridge

Special Survey - Vicinity of piers of Golden Gate Bridge, 12 October 1964

The purpose of the survey was to take soundings at easily relocated positions to check erosion in the vicinity of the piers of the Golden Gate Bridge.

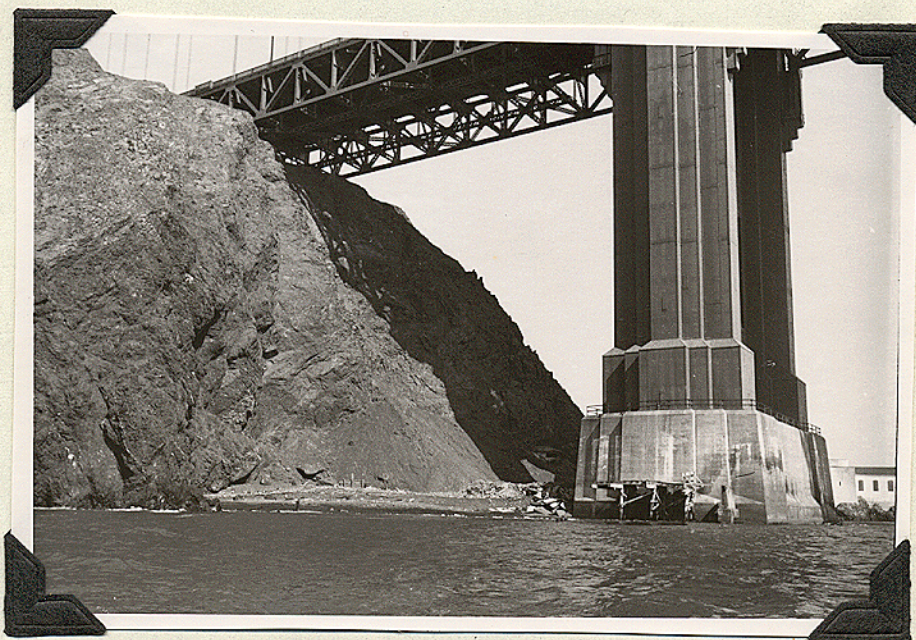
PLATE # 2
VICINITY OF NORTH PIER

NORTH PIER (MARIN PIER)

Work on the North pier was accomplished using tag lines for control. One $\frac{1}{4}$ " stainless steel cable was used. It was 275 feet long and marked with a tag every 25 feet. The bridge authority supplied the cable, the same one used in previous surveys. A lead line marked in feet was used to measure the depth. The boat was a heavy duty 16 foot rowboat powered by a 10 HP Johnson engine with gear shift. Three men on the pier and three men in the boat were necessary. One man was required ashore to read the tide staff at Fort Point Coast Guard Station. A reading of 2.0 feet on the tide staff was used as MLLW. All shore personnel were supplied by the bridge authority.

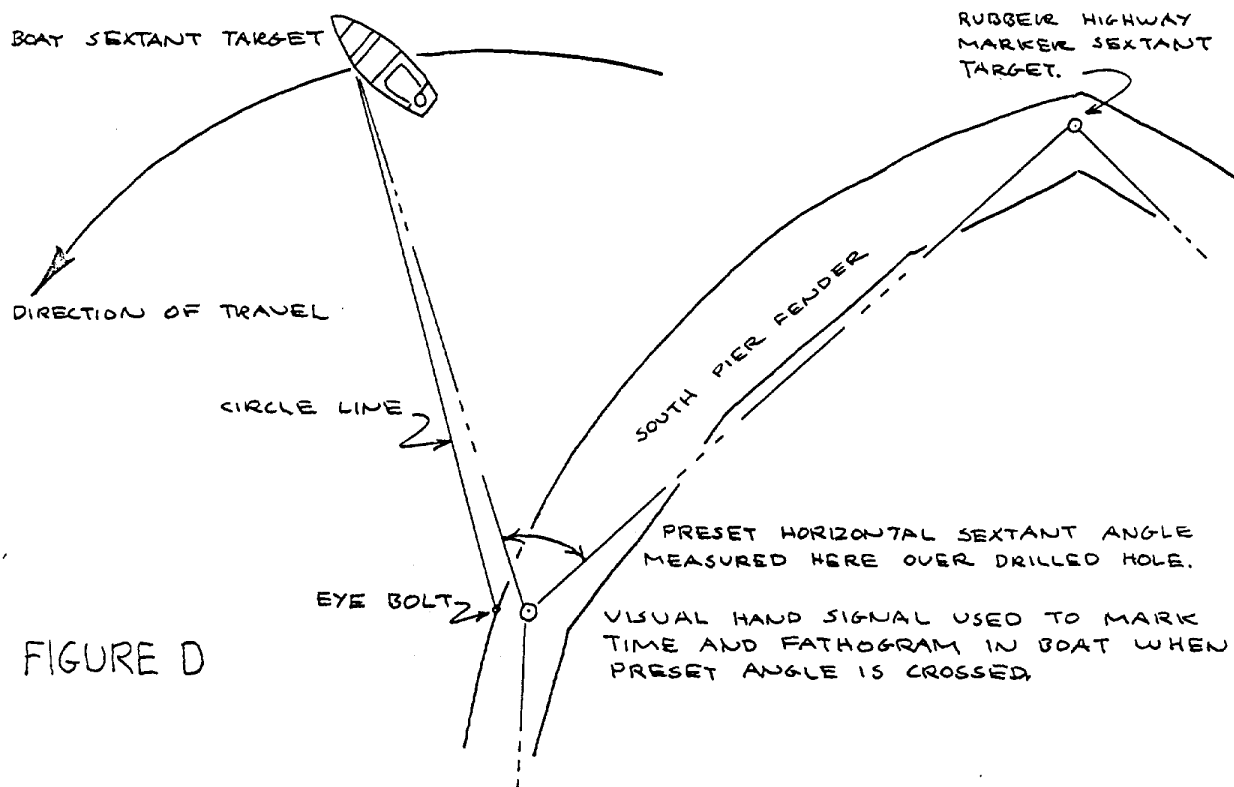
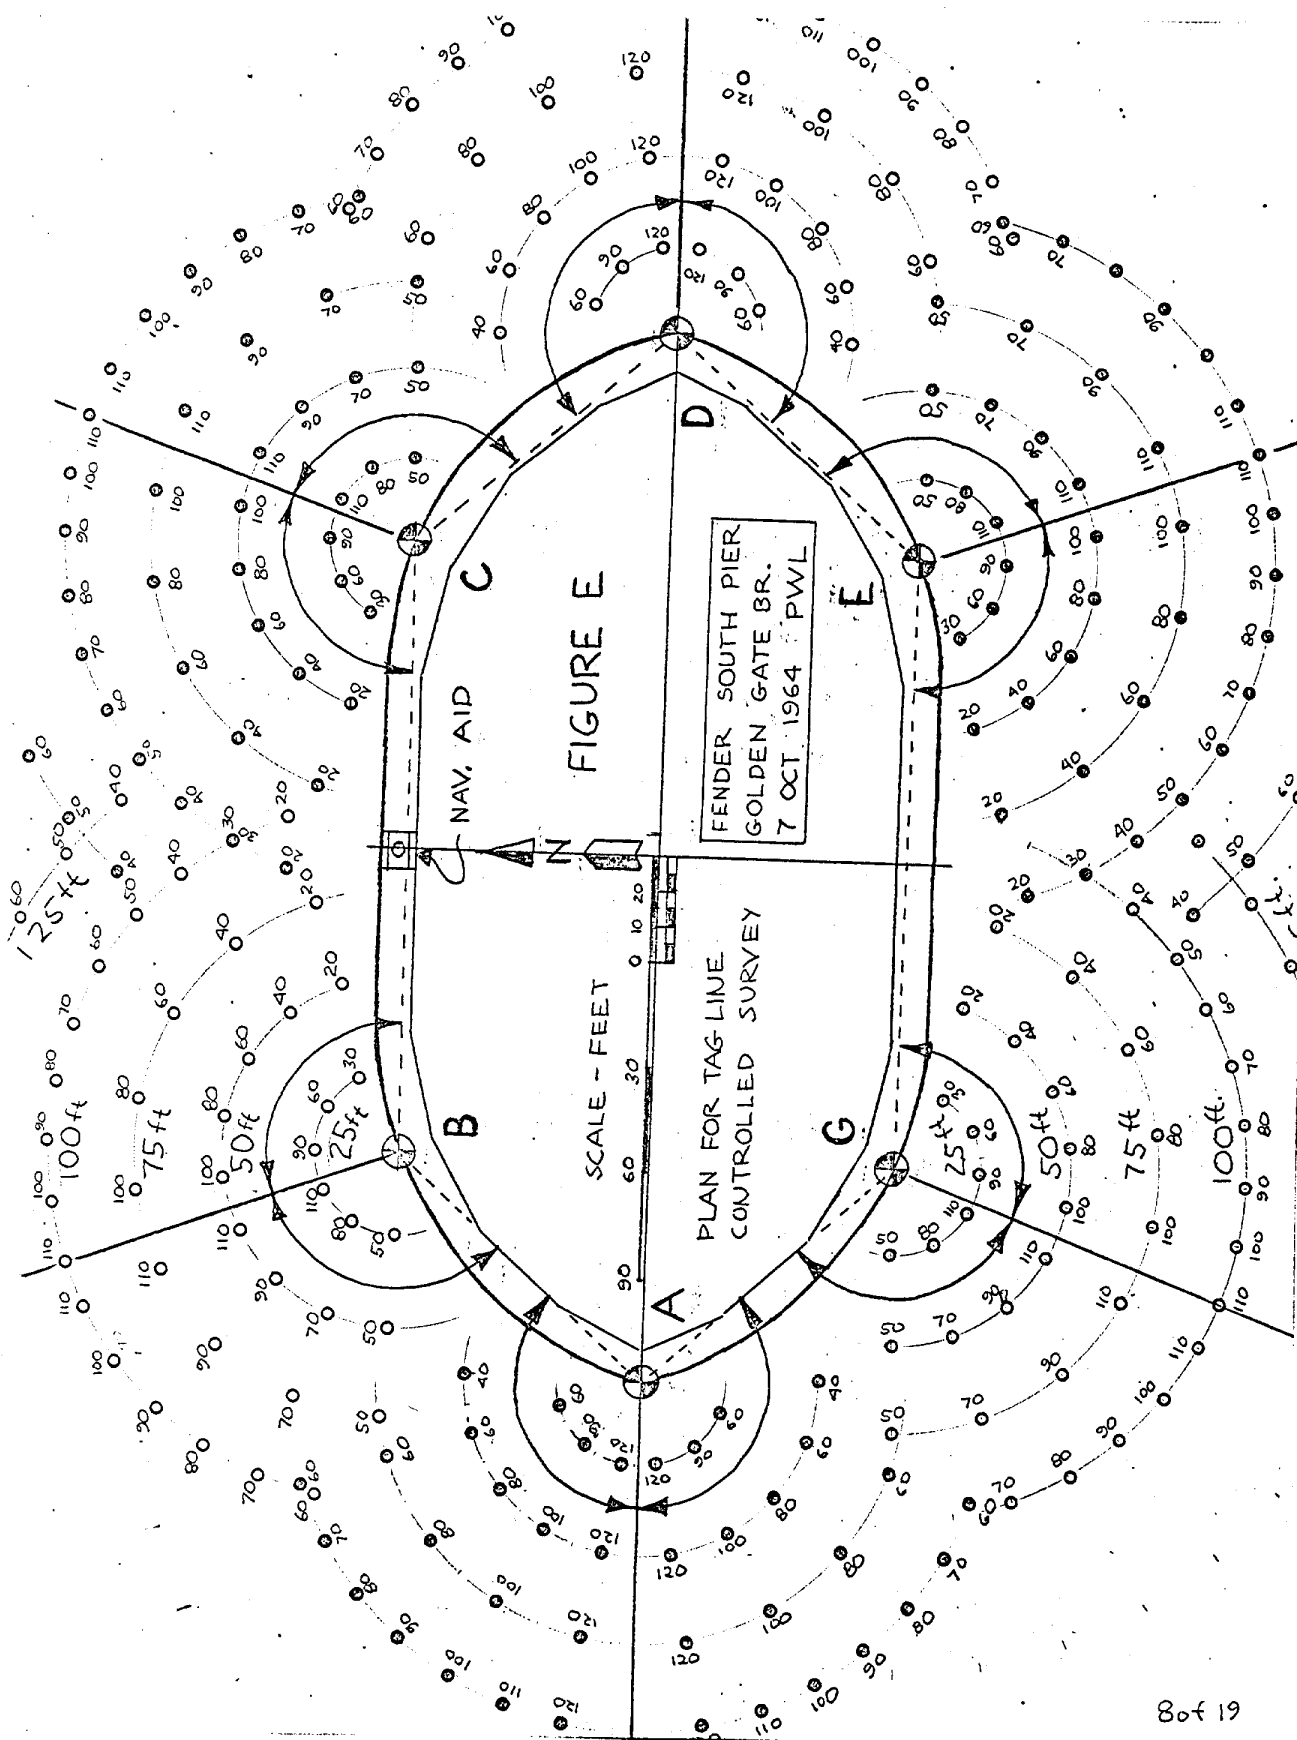
Six eye bolts were set in the face of the fender enclosing the south pier by bridge authority employees as prescribed by the officer in charge. On the top of the fender, holes were drilled to mark the location of the eye bolts. It was found that due to the strong currents and seeming lack of slack water in the vicinity of the South Pier the tag line method would not work. Therefore the circle line method was adopted using only one tag line and a sextant angle to define position. Because of the depth and current it was decided to use a fathometer instead of a leadline. The system proved quite workable and a description follows.

The survey positions were pre - planned as shown on figure (E) and the sextant man preset his angles and gave a visual hand signal "mark" to the recorder in the boat as it swung in a circular arc as shown in figure (D).

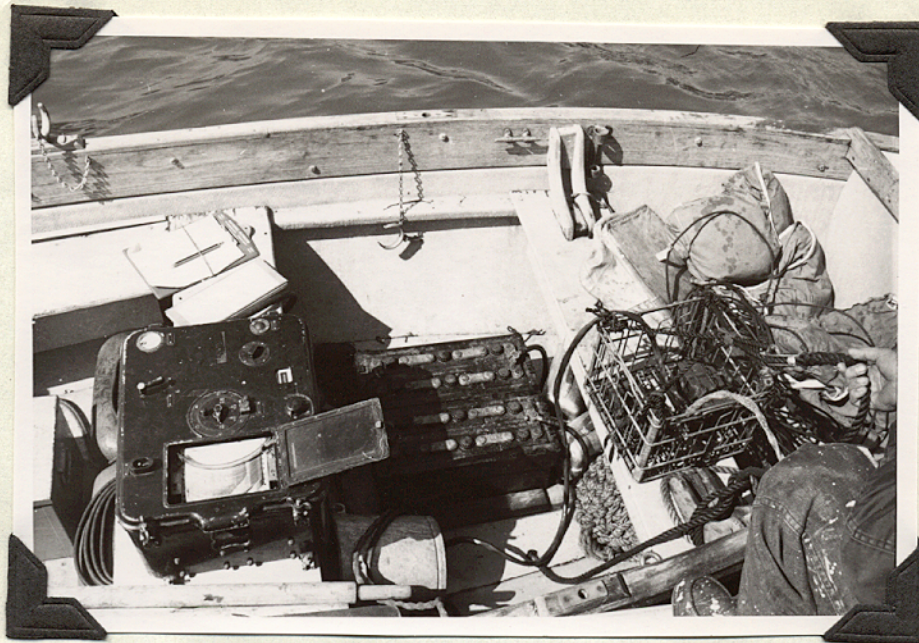
PLATE # 3

Plates three and four show the wire basket in which the transducers were tied and the general orientation of equipment in the boat.

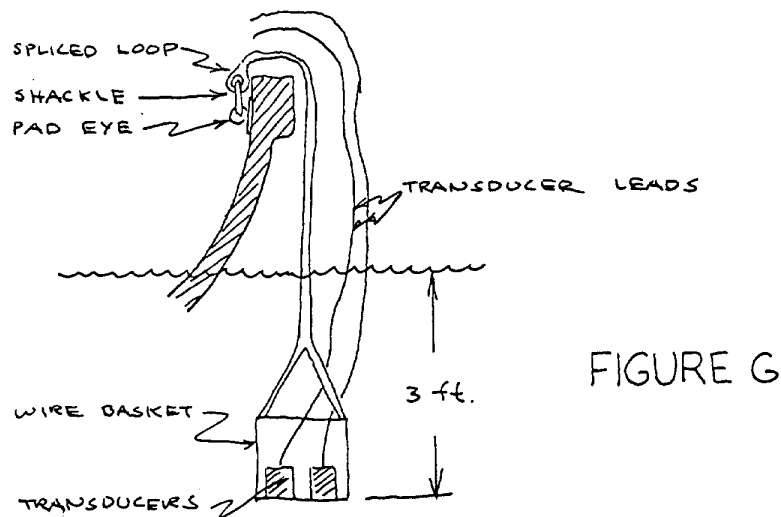
FIGURE G

Figure G. Mounting the transducers in an open wire basket kept them hanging more or less vertically while the boat rocked. No problems with side echos were experienced. The open wire basket gave little lateral resistance and the current had little effect upon the orientation of the transducers. Due to the proximity of the transducers it was impossible to eliminate the initial, limiting this method to water at least 12 to 15 feet deep.

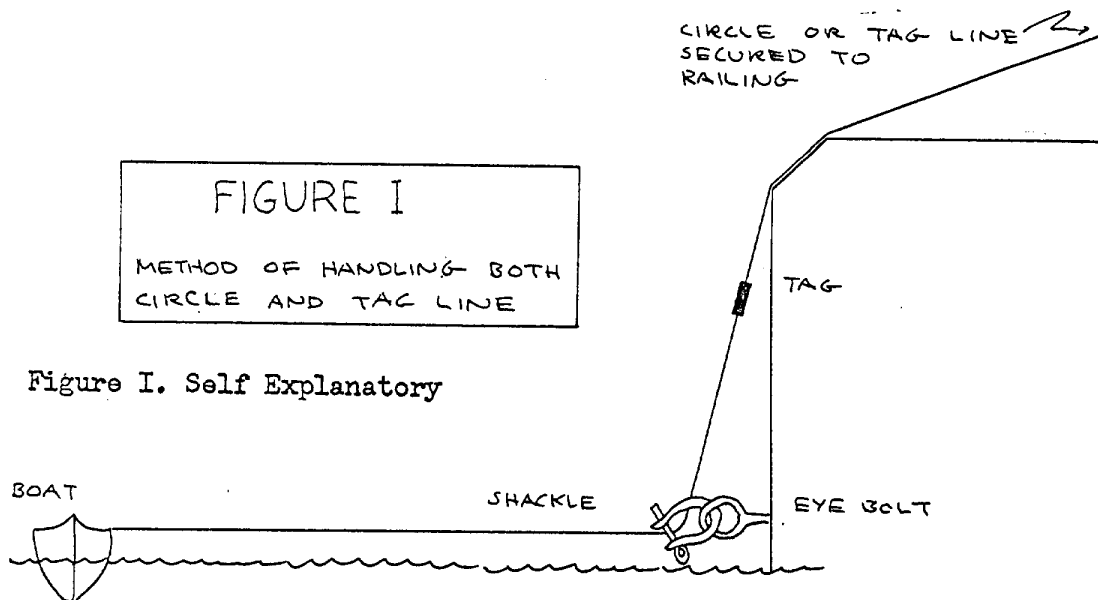
Figure I. Self Explanatory

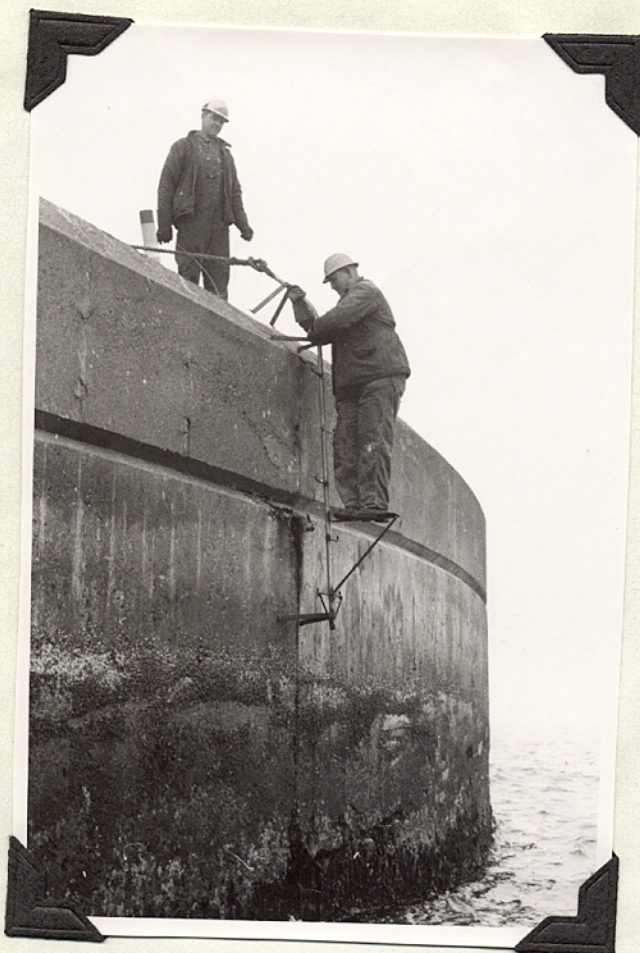
PLATE # 5

A special ladder was used by Bridge personnel to handle the tag line.

See Plate # 5.

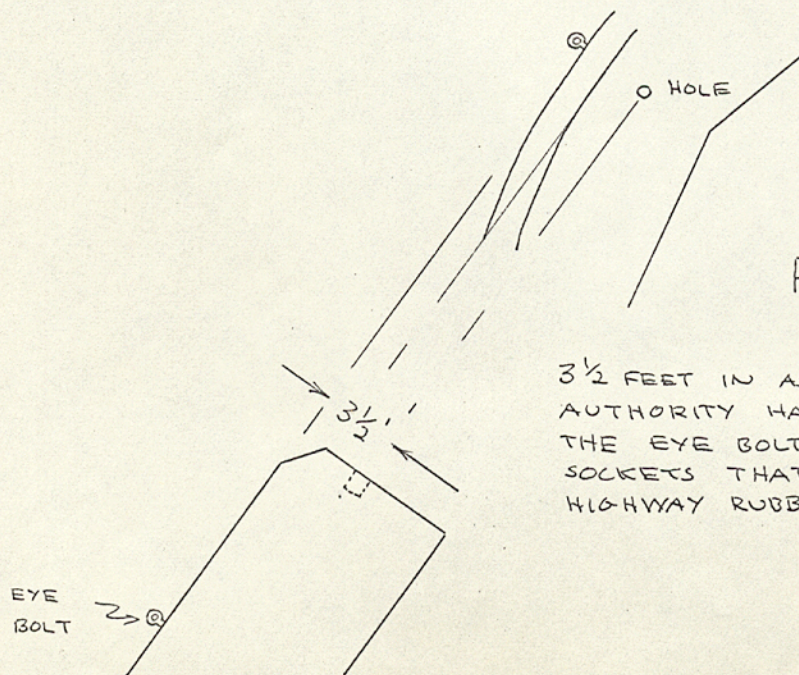
FIGURE J

See figure J for a description of eye bolts and target hole location.

3 1/2 FEET IN AS SHOWN THE BRIDGE
AUTHORITY HAS DRILLED HOLES ABOVE
THE EYE BOLTS AND INSERTED METAL
SOCKETS THAT HOLD THE STANDARD
HIGHWAY RUBBER LANE MARKER

The target holes were located with a closed loop travers used in plotting.

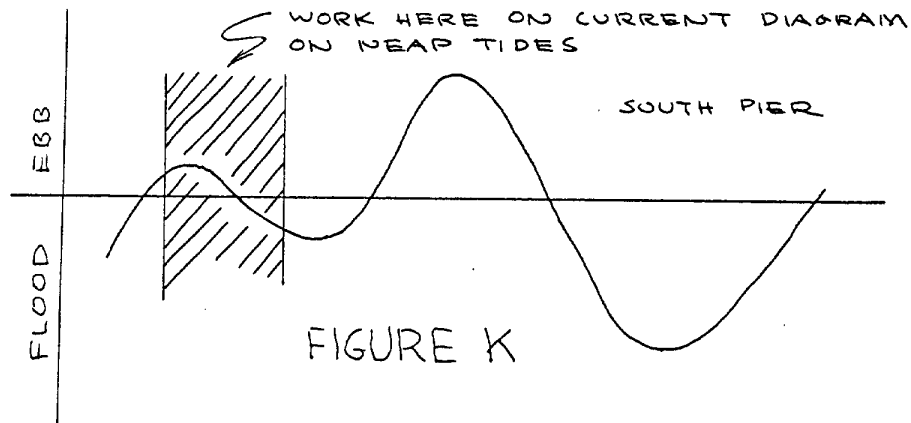
Weather and current conditions:

It was found in the course of operations that the only satisfactory time to work in the vicinity of the South Pier was as shown on figure K.

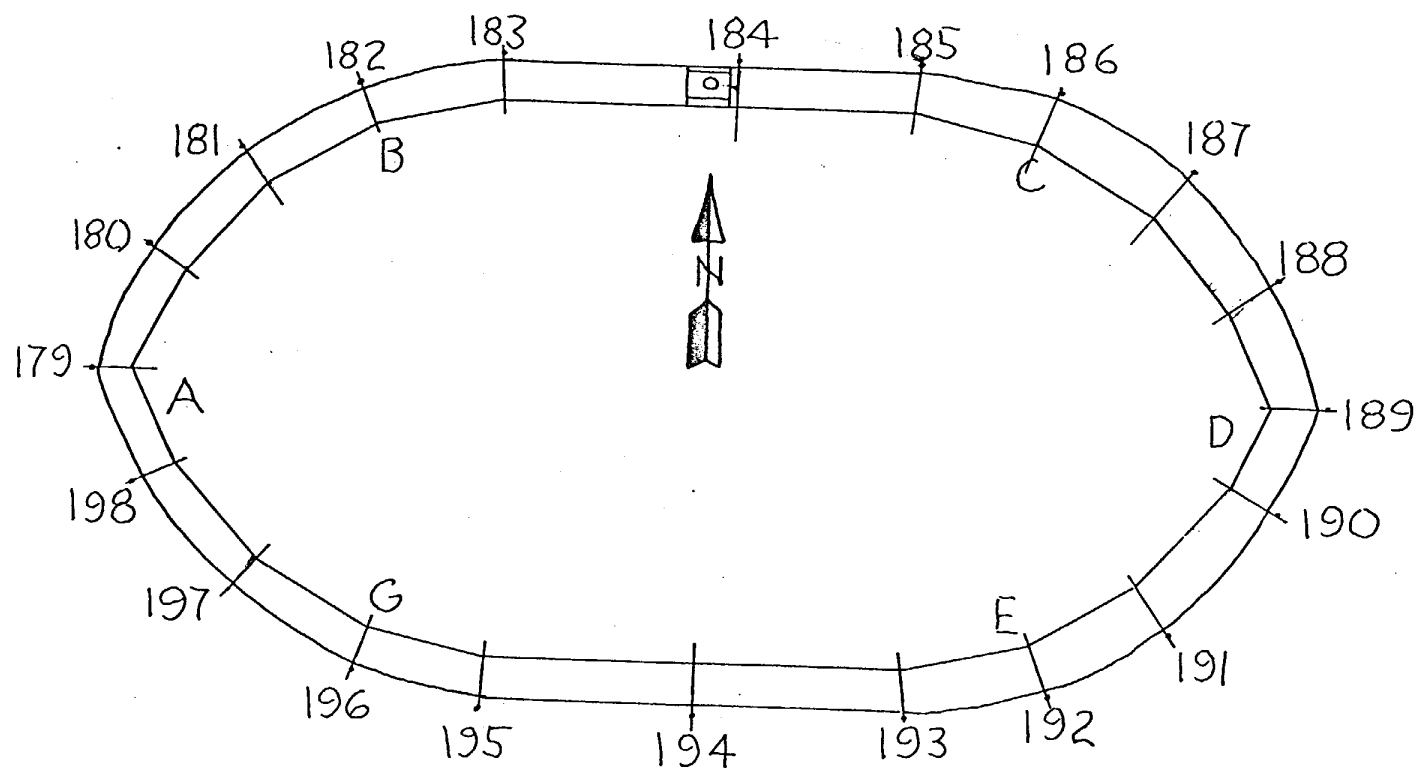
POSITION NUMBERS 179 to 198 SHOW THE LOCATION OF LEAD LINE SOUNDINGS TAKEN ALONG THE FACE OF THE FENDER AT THE SOUTH PIER OF THE GOLDEN GATE BRIDGE. SOUNDINGS WERE TAKEN OPPOSITE THE INTERIOR ANGLES OF THE FENDER AS SHOWN. POSITIONS 184 AND 194 WERE TAKEN AT THE NORTH EAST CORNER OF THE NAVIGATIONAL STRUCTURE AND OPPOSITE A LARGE CYLINDRICAL BOLLARD ON THE SOUTH SIDE OF THE FENDER RESPECTIVELY.

A comparison between H-7717 (1948) scale 1:2400 and the present survey reveals a deepening of 2-5 ft. in most areas around the South Pier. Scouring of 10 ft. is indicated next to the pier in several places. Prior depths of 103 to 110 ft. found in a slight deep 50 ft. off the northeast face of the pier have shoaled to about 93 ft. About 35 ft. beyond the prior deep, scouring of 10 ft. has occurred in prior depths of 93 to 104 ft.

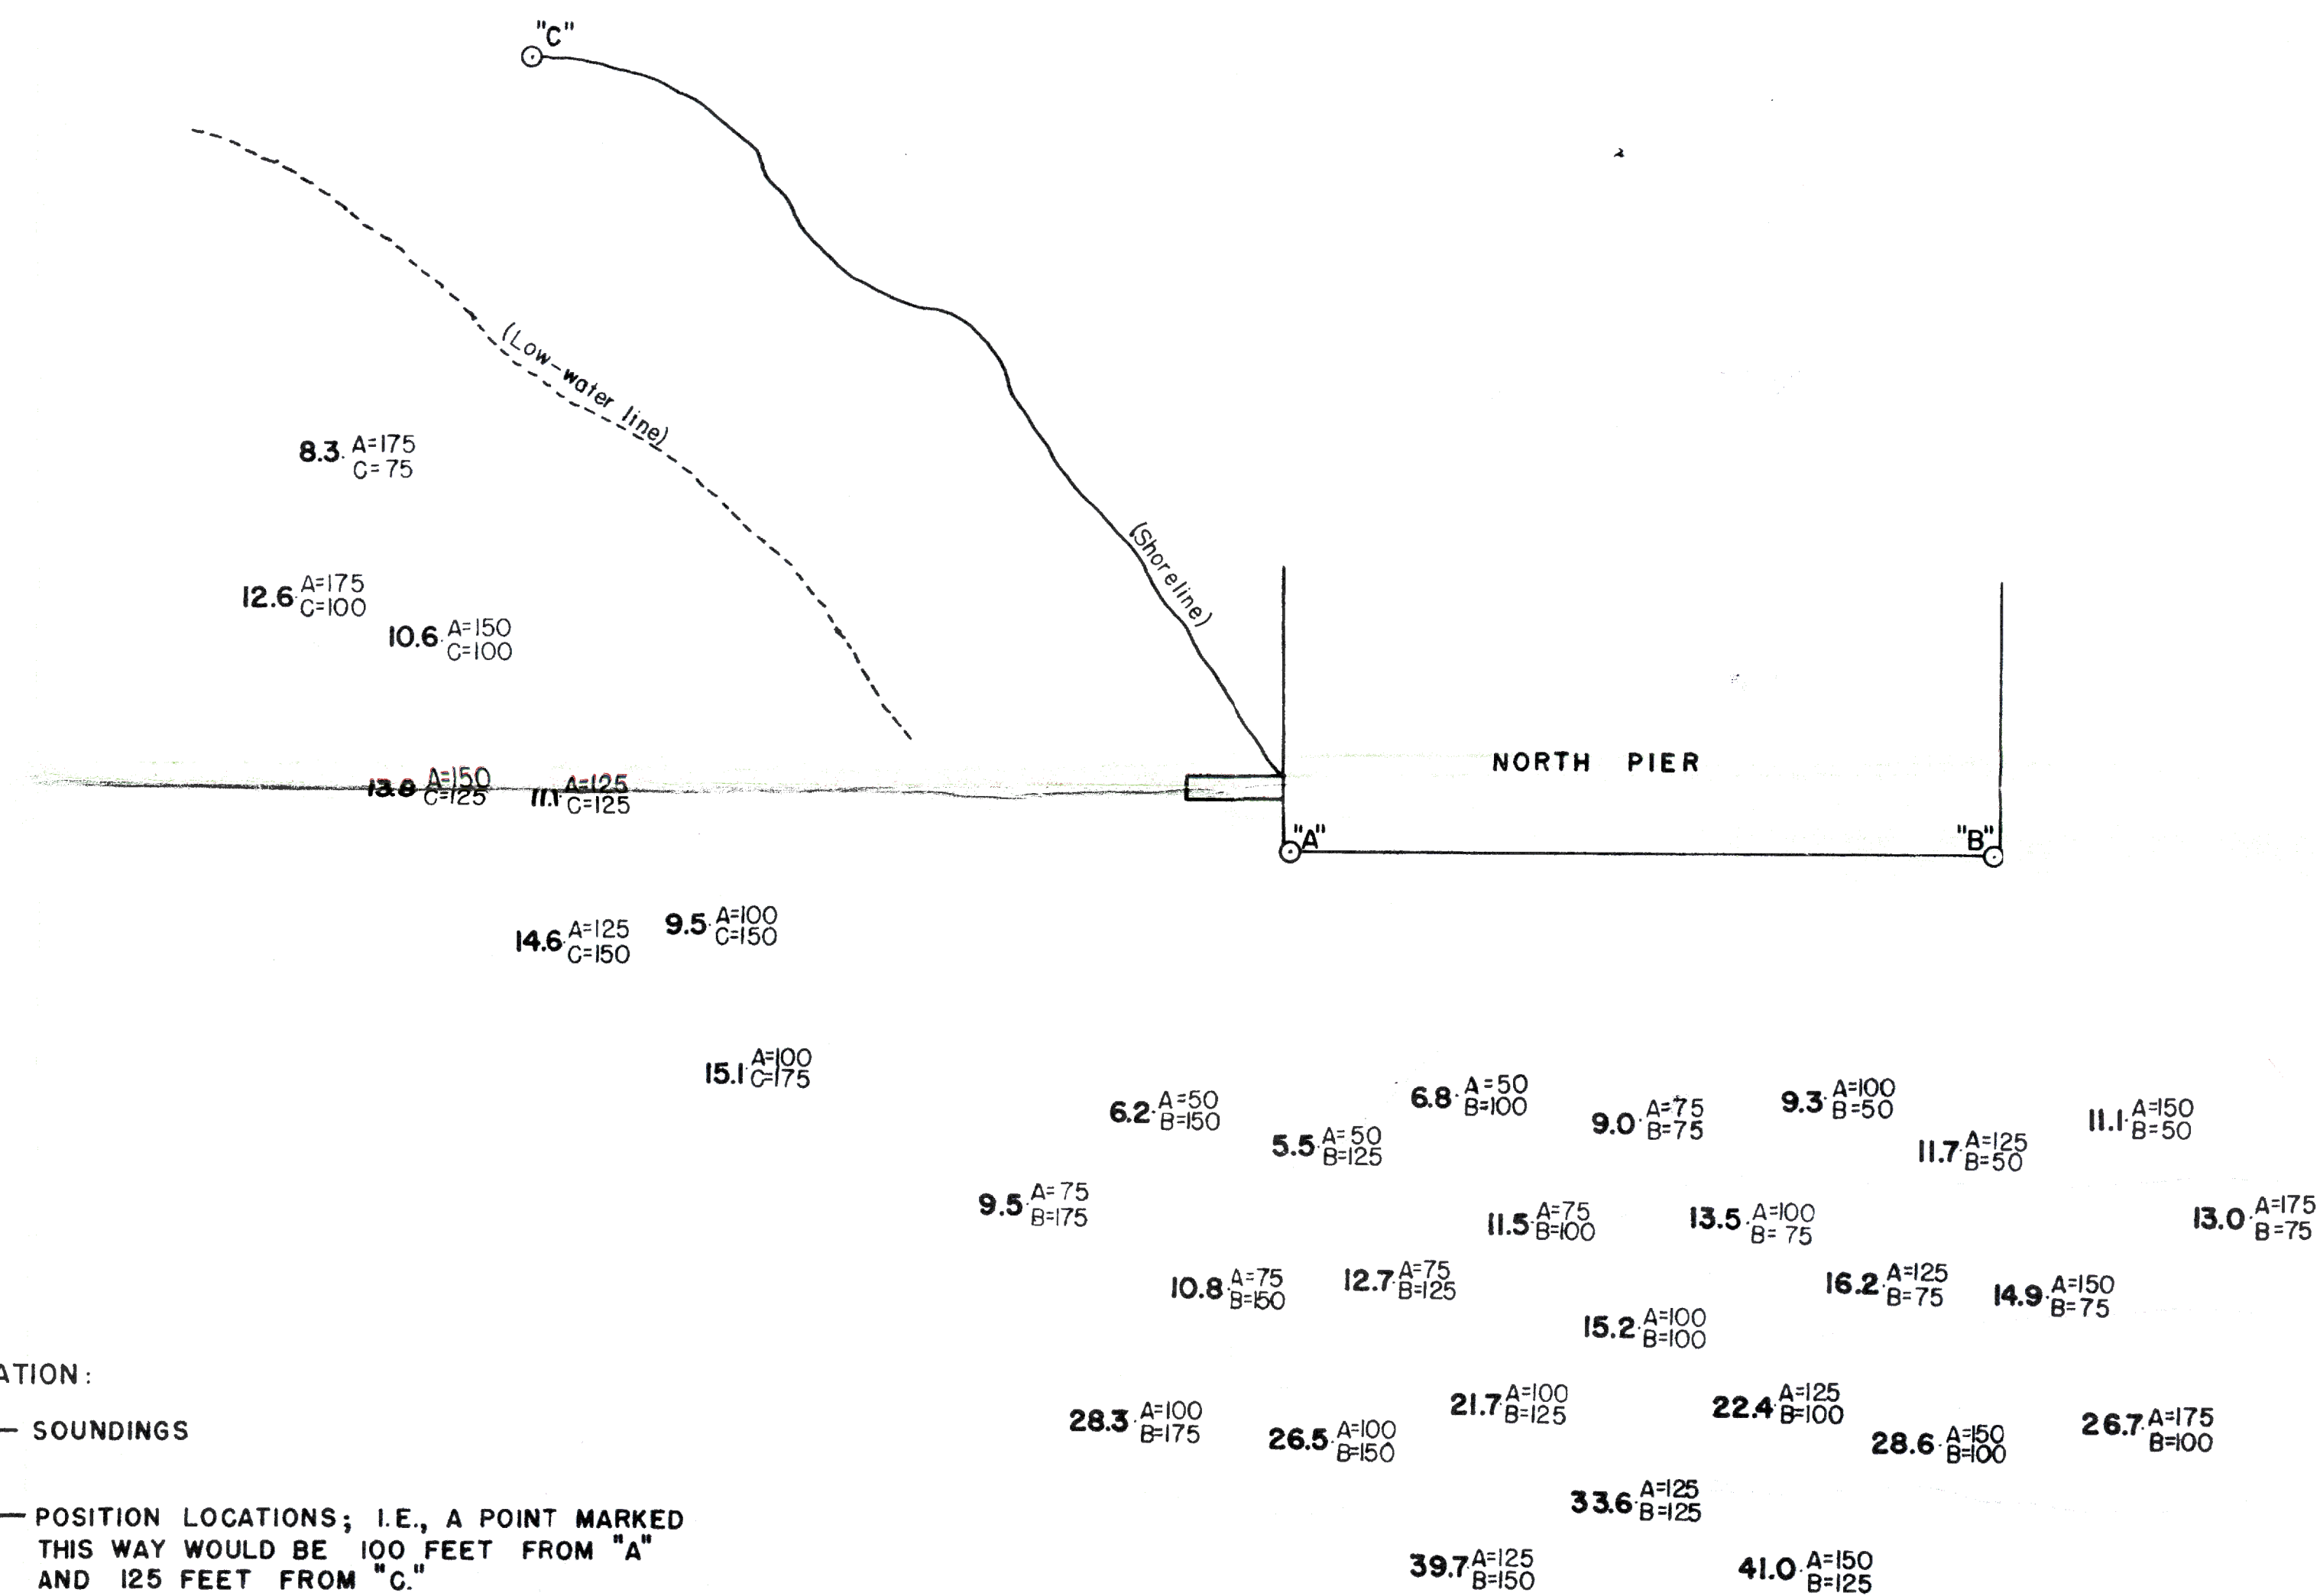
GOLDEN GATE BRIDGE
NORTH (MARIN) PIER

EXPLANATION:

23.1 — SOUNDINGS

A=100
C=125 — POSITION LOCATIONS; I.E., A POINT MARKED THIS WAY WOULD BE 100 FEET FROM "A" AND 125 FEET FROM "C."

BLACK DOT BETWEEN POSITION NUMBER AND DEPTH SOUNDING IS ACTUAL PLACE SOUNDING WAS MADE

SOUNDINGS IN FEET
AT MEAN LOWER LOW WATER

Comparison between FE 1 (1956) and the present survey in the vicinity of the North Pier reveals a deepening of 3 to 4 ft west of the pier, little change from southwest of the pier to south of the center and a deepening of 2 ft. south of the east half of the pier. However, south of the pier in depths of about 40 ft. a deepening of 3-4 ft has occurred.
